## FLUTTER TESTS OF B-34 FIN-RUDDER-TAB SYSTEM

By Theodore Theodorsen and N. H. Smith

MEMORANDUM REPORT

Army Air Forces, Materiel Command

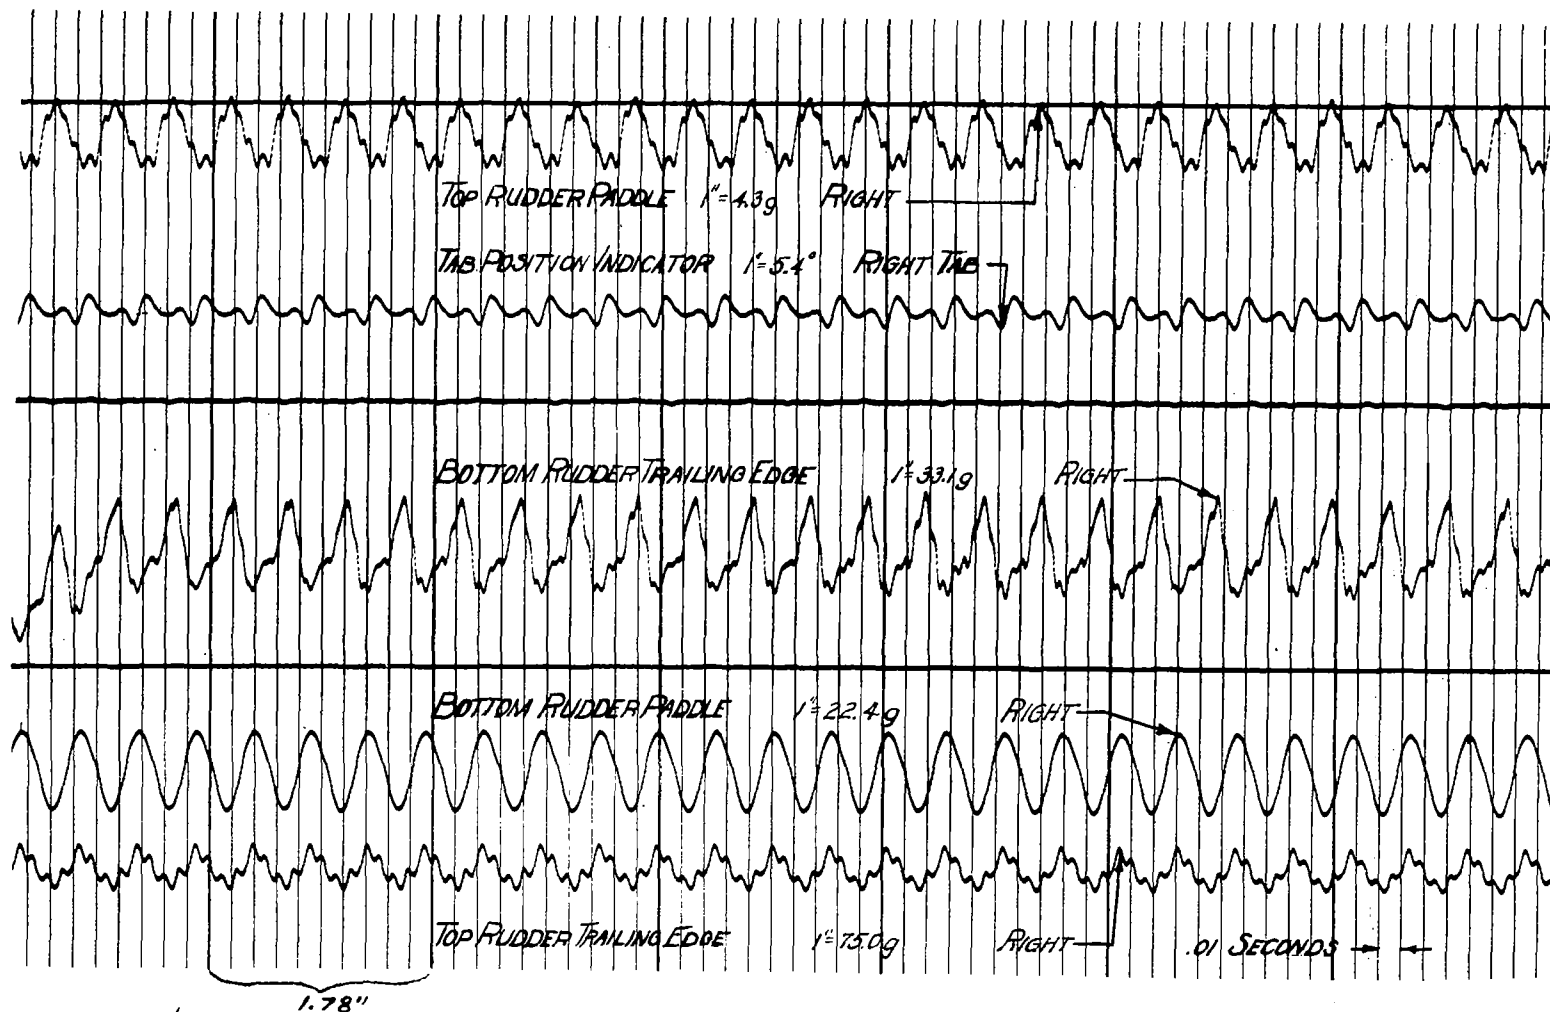
Data from vibration tests at zero airspeed, which were made in the tunnel before each flutter test, are recorded in table I. A typical oscillograph record for rudder torsion is shown in figure 4. In all tests a heavy tab, having a moment of inertia of 0.102 inch-pound-second<sup>2</sup> about its own hinge line, was used.

Figure 4.- Oscillograph record with rudder-torsion shaker on lower-rudder trailing edge.

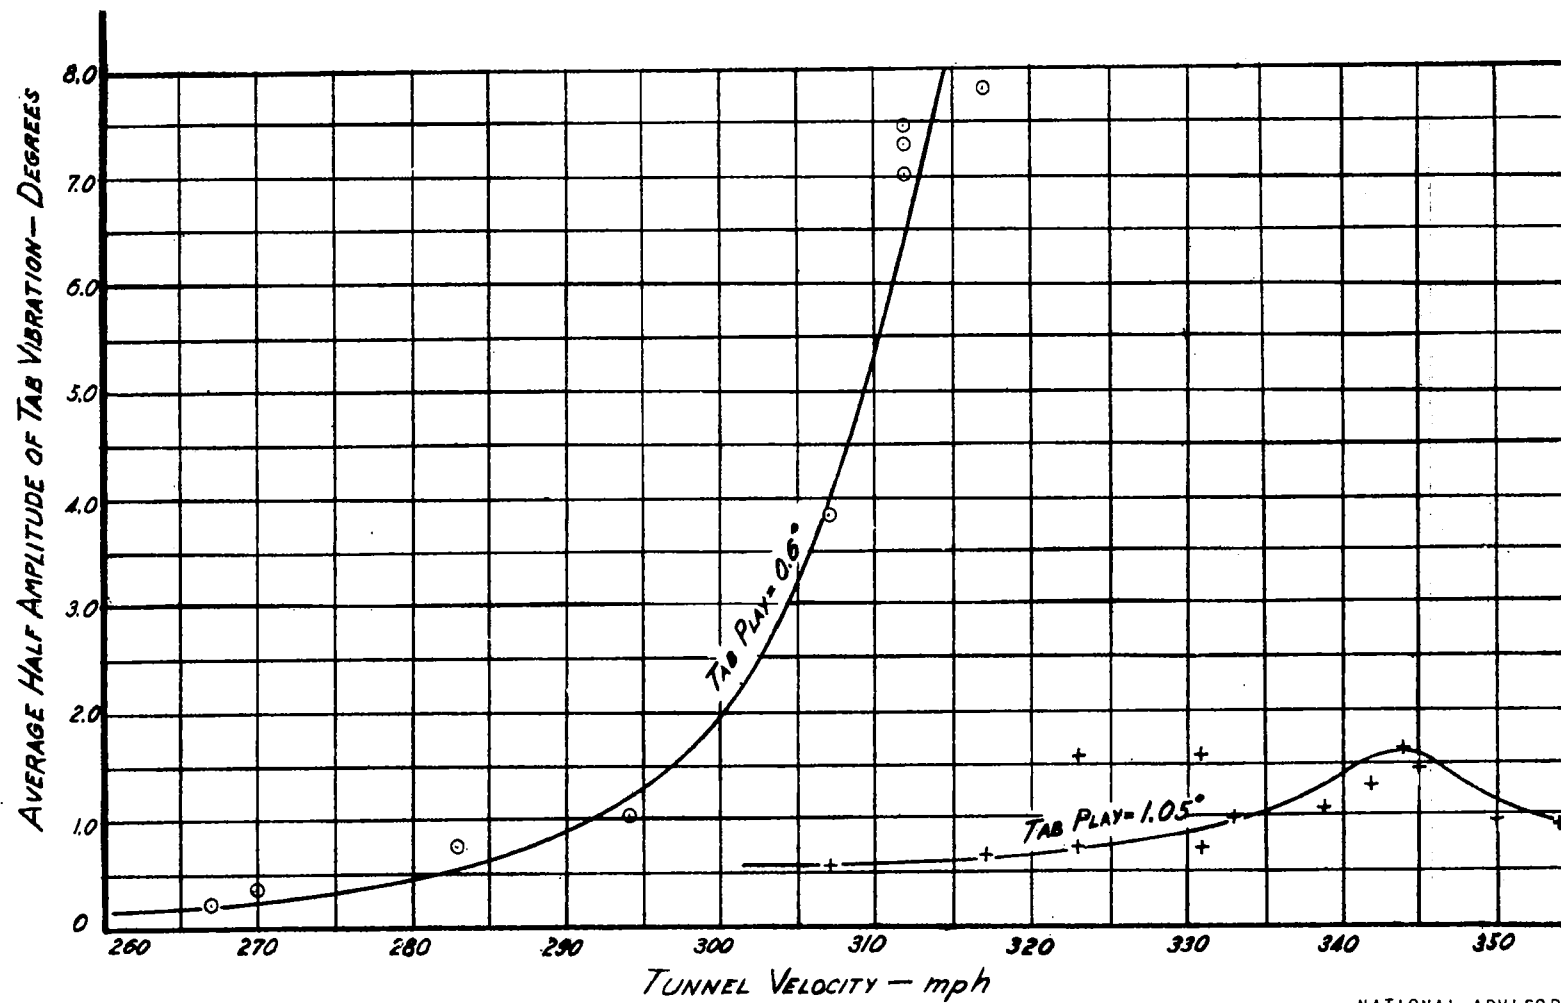
After the vibration tests, the run was repeated without repairs to the rudder surface. The tunnel velocity was increased gradually and oscillograph records were taken frequently. A plot of tab amplitude against tunnel velocity for the range between 260 and 315 miles per hour (tab play,  $0.6^\circ$ ) is given in figure 6. A typical oscillograph record of the resulting mild tab flutter is shown in figure 7. The frequency and phases measured from a similar record are given in table II.

Figure 6.- Amplitude of tab motion as a function of tunnel velocity.

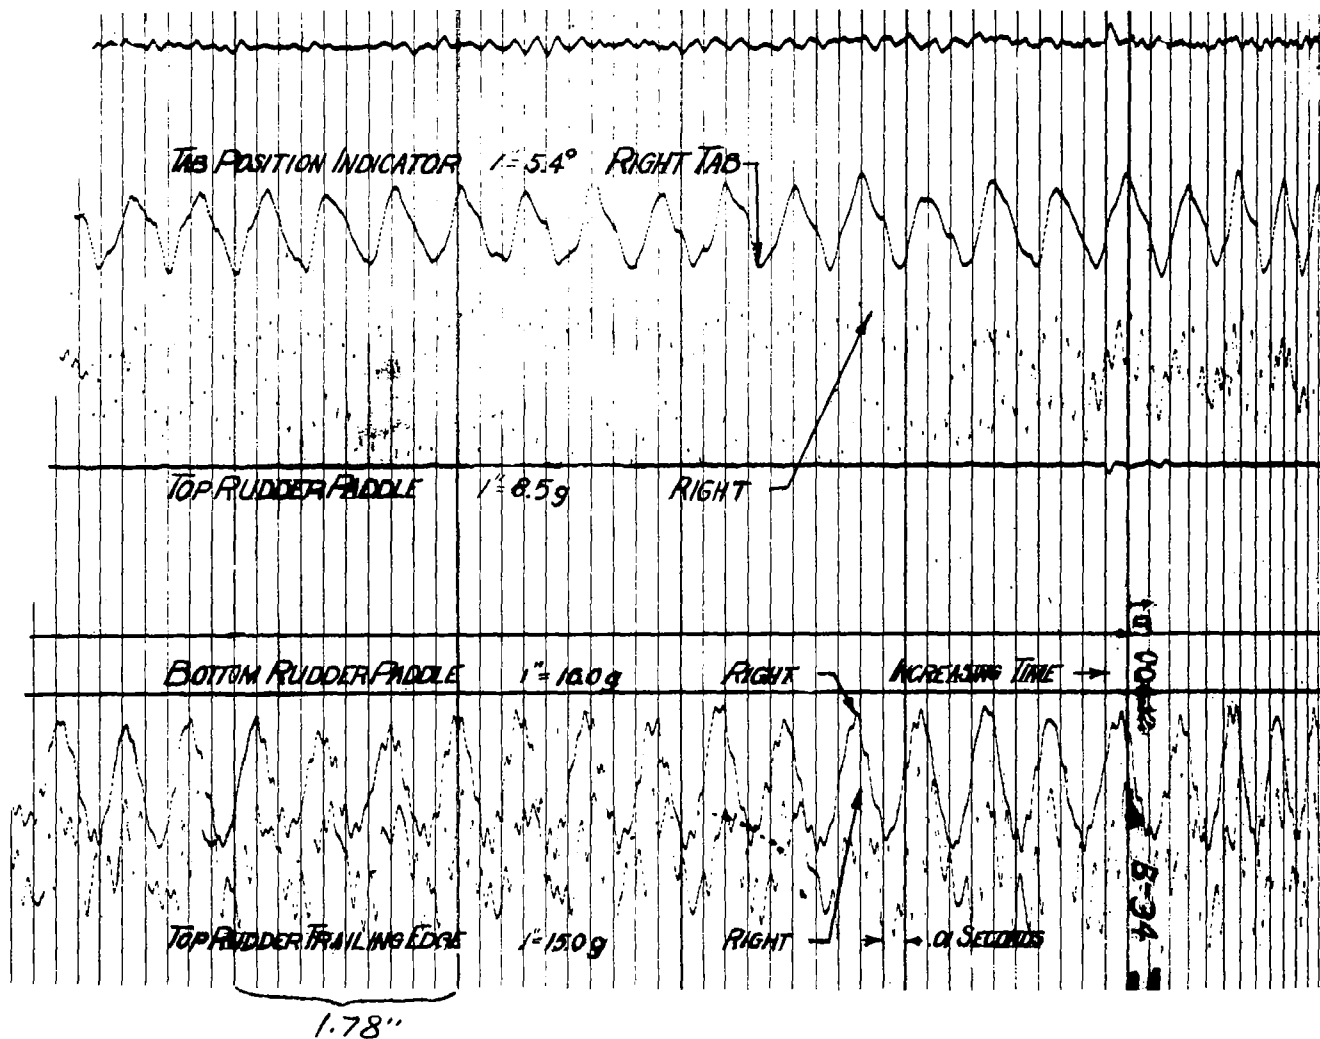
For condition (2), the amount of tab play was increased to  $1.05^\circ$  by machining one of the tab push-rod bearing bolts to a smaller diameter than standard. Tunnel velocities were again increased until a velocity of 354 miles per hour was reached without flutter. The oscillograph records show tab motion of small amplitude, however, at a frequency of 34 cycles per second. Amplitudes from these records are plotted in figure 6. A typical oscillograph record obtained from tests made under condition (2) is shown in figure 8. This test was discontinued because it was feared that the flutter would be severe, as the earlier tunnel velocity (for condition (1)) had been exceeded by a considerable amount.

Figure 8.- Typical oscillograph record showing mild flutter. Tab play,  $1.05^{\circ}$ ;  $V = 344$  mph;  
 $M = 0.440$ ; tab frequency, 32.5 cps.

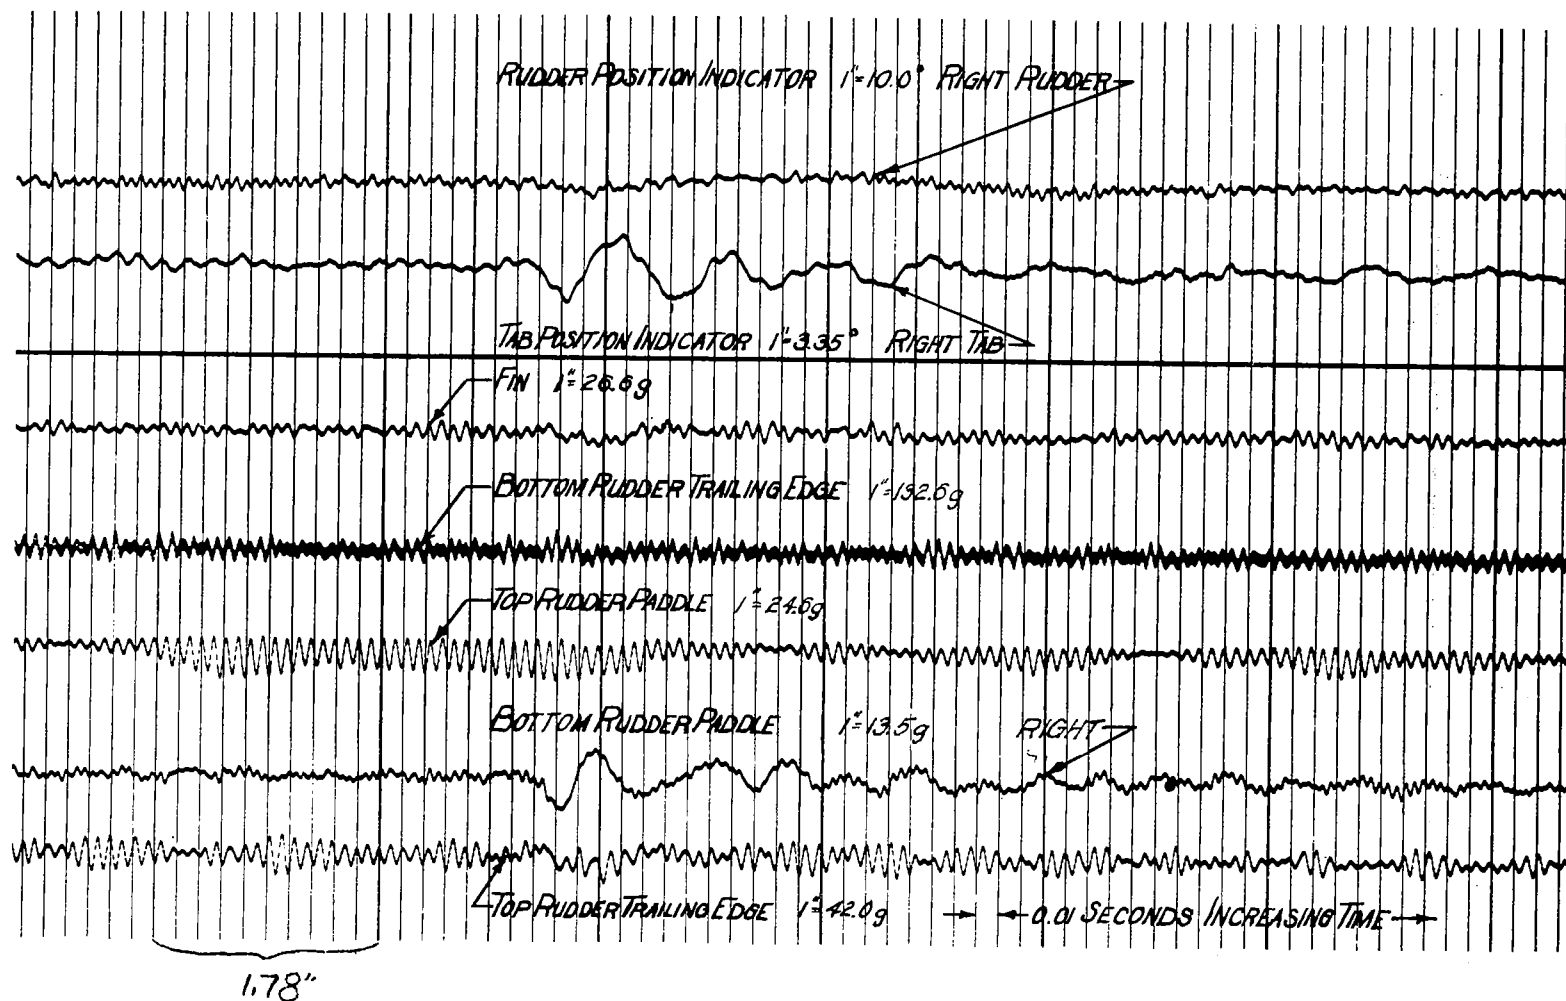
During the test in the tunnel one end of the steel cable was jerked at tunnel velocities of 275, 301, 311, and 321 miles per hour. The resulting oscillograph record taken at 311 miles per hour is reproduced in figure 11. At 321 miles per hour flutter was started by jerking one end of the cable, was damped by pulling on both ends of the cable, and became severe when the cable was released. Pulling the cable ends failed to restrain this large-amplitude flutter because one of the pulleys broke. An oscillograph record of the flutter at 321 miles per hour is given in figure 12. Data from this record are given in table III. When the tunnel was shut down, it was found that rivets in the horizontal stabilizer had been pulled, the fin had a list, and the tab was locked in right position.

Figure 11.- Oscillograph record taken when rudder was jerked. Tab play,  $0.4^\circ$ ;  $V = 311$  mph;  
 $M = 0.398$ ; tab frequency. 20 cps.

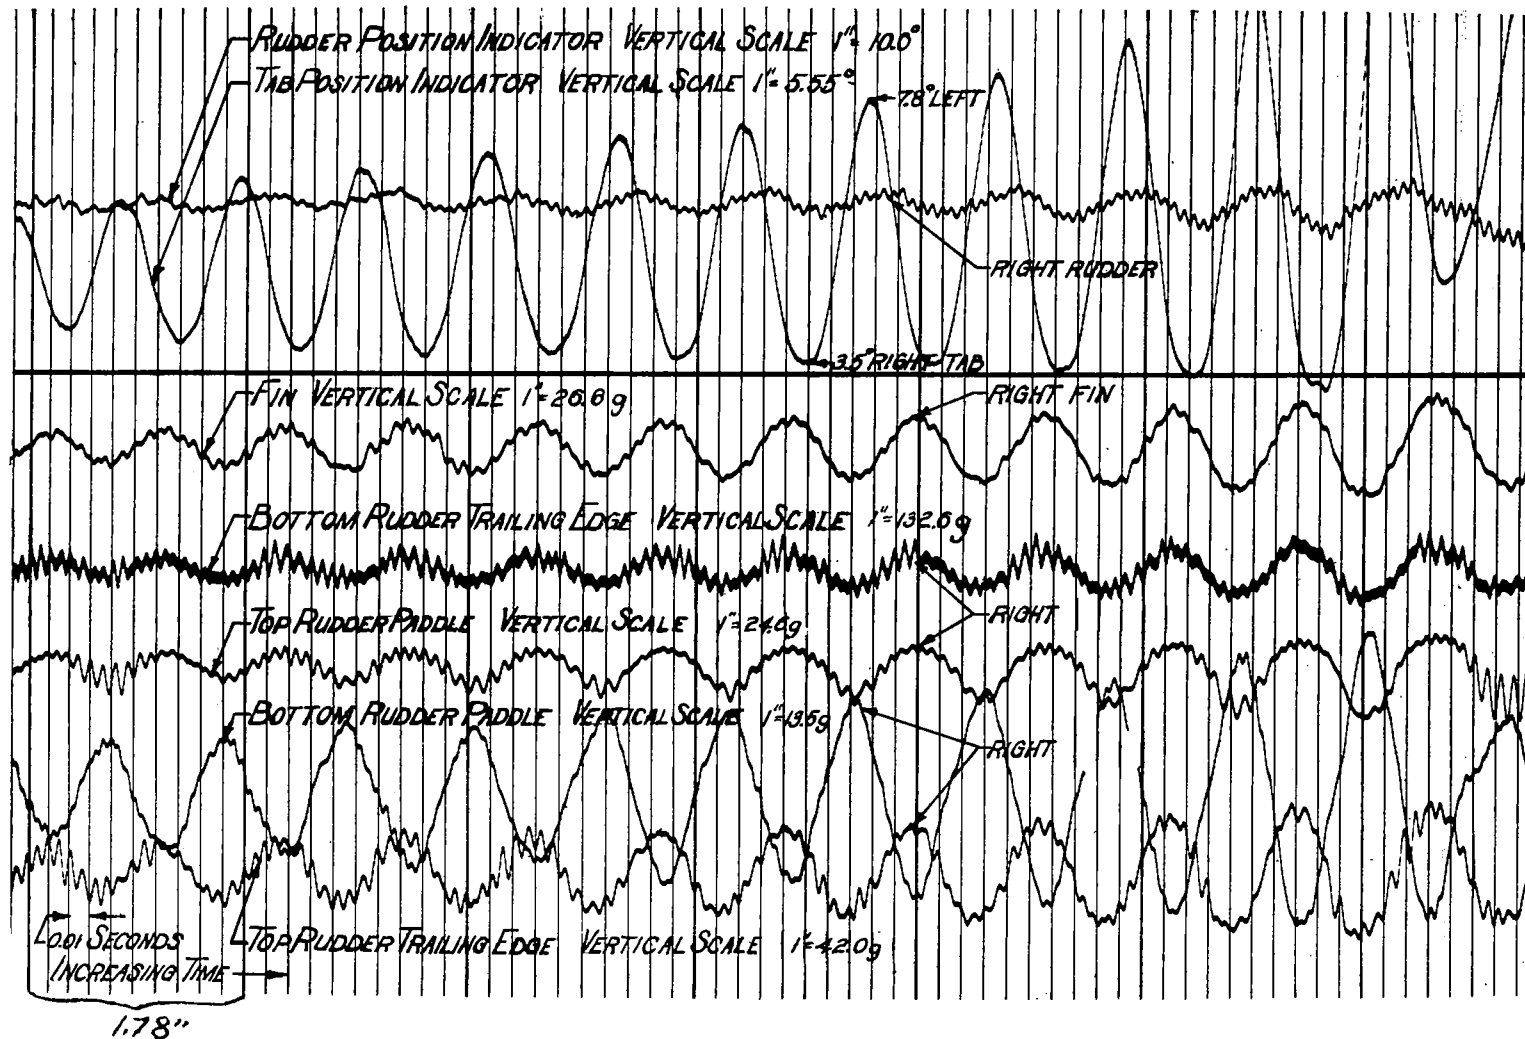
Figure 12.- Oscillograph record for case of severe flutter. Tab play,  $0.4^\circ$ ;  $V = 321$  mph;  
 $M = 0.411$ ; tab frequency, 20 cps.
